June 1983

Site Investigation Syosset Landfill Oyster Bay, New York

Peter M. Stokely, Imagery Analyst

**ENVIRONMENTAL MONITORING SYSTEMS LABORATORY
OFFICE OF RESEARCH AND DEVELOPMENT
U.S. ENVIRONMENTAL PROTECTION AGENCY
LAS VEGAS, NEVADA 89114**

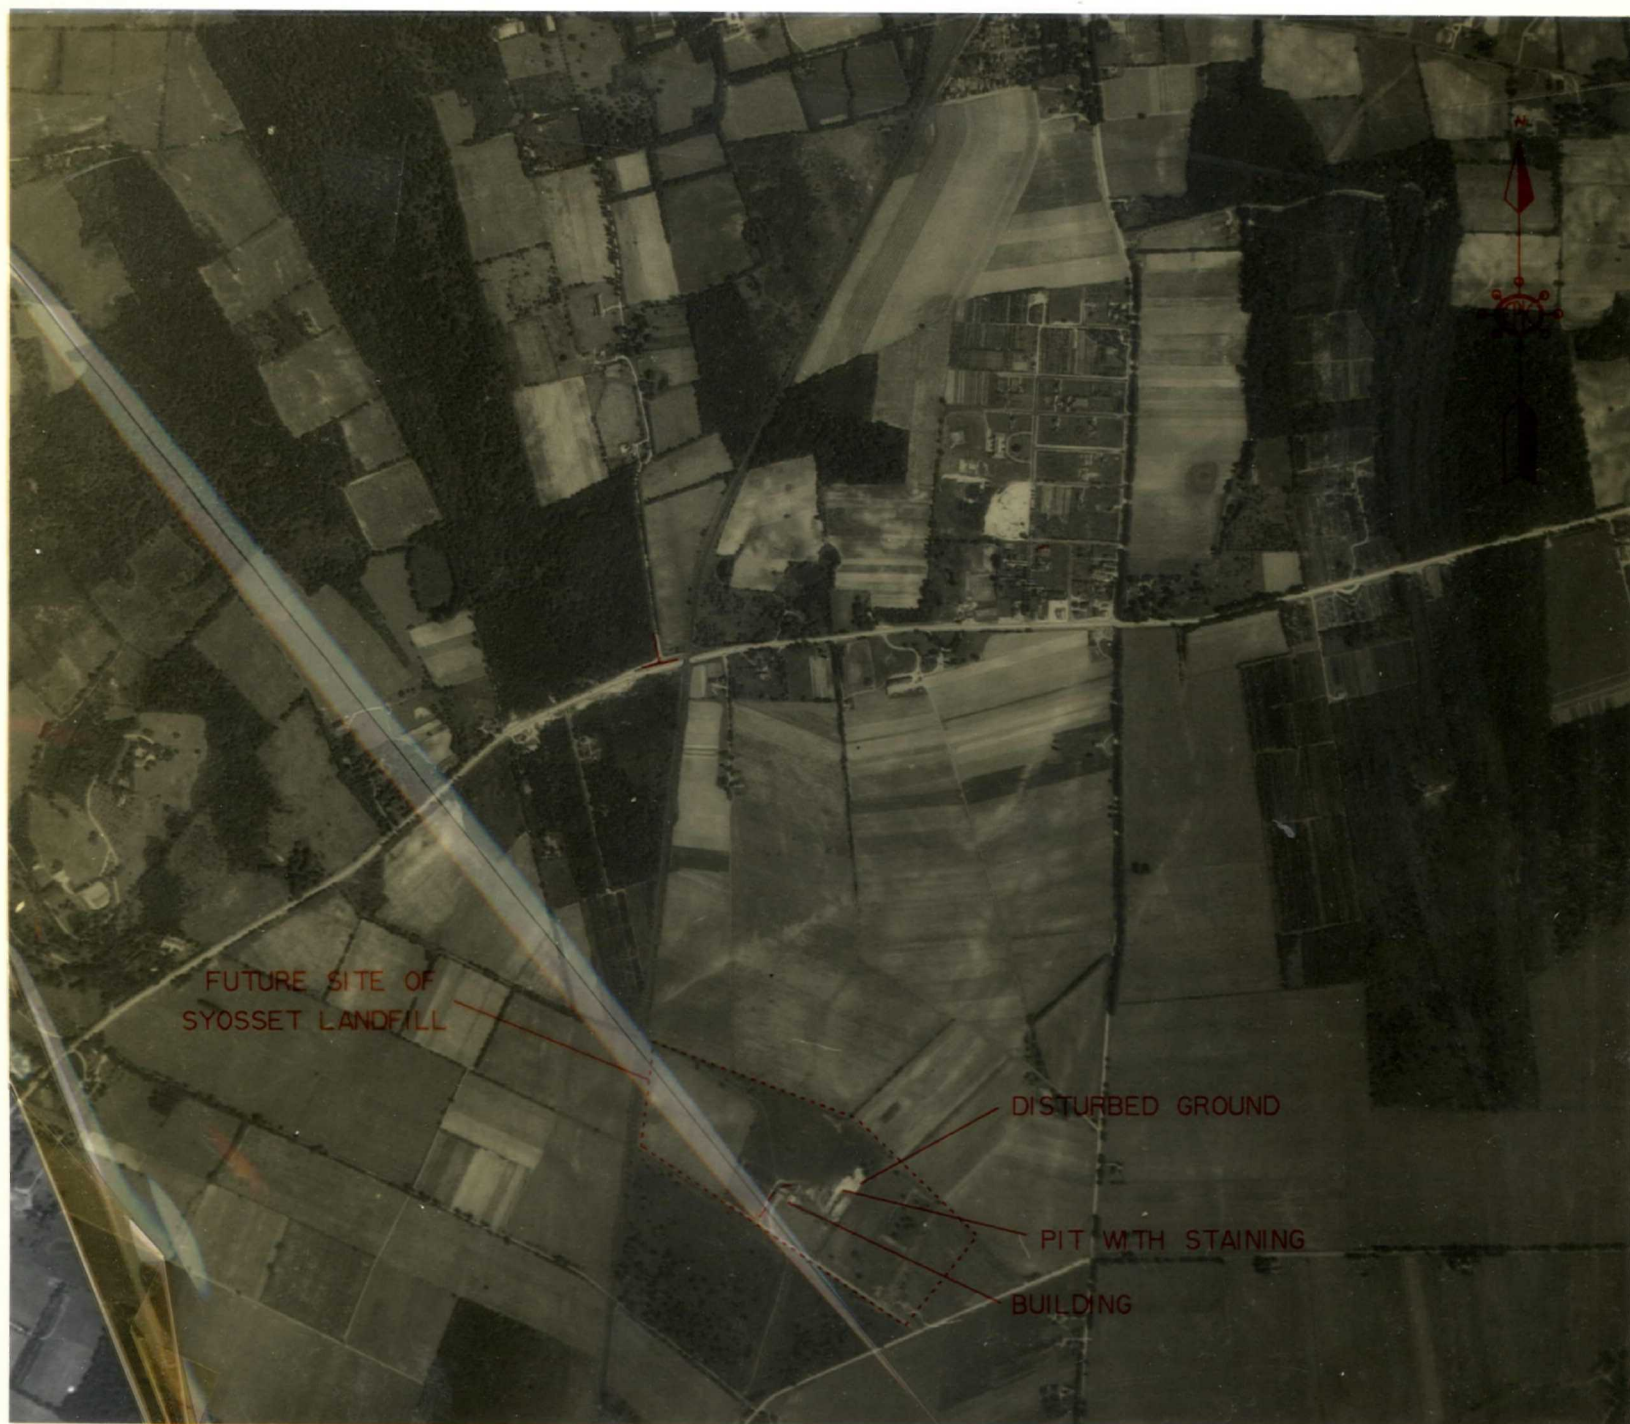
SYOSSET LANDFILL AUGUST 3, 1938 APPROX SCALE 1:17,000

The future location of the Syosset Landfill is outlined on the 1938 photograph. On site in 1938 are the following: a building with a possible smokestack, an access road leading to the building, a pit with dark staining and disturbed ground that surrounds the pit. No other features were seen on site in this photograph. The land surrounding the site is primarily agricultural.

- 1938 - (Photo 1) This is the first year analyzed. A building with a possible smokestack, a pit with staining, and disturbed ground appear on site. This building is in the same location as the incinerator that appears in the following years.

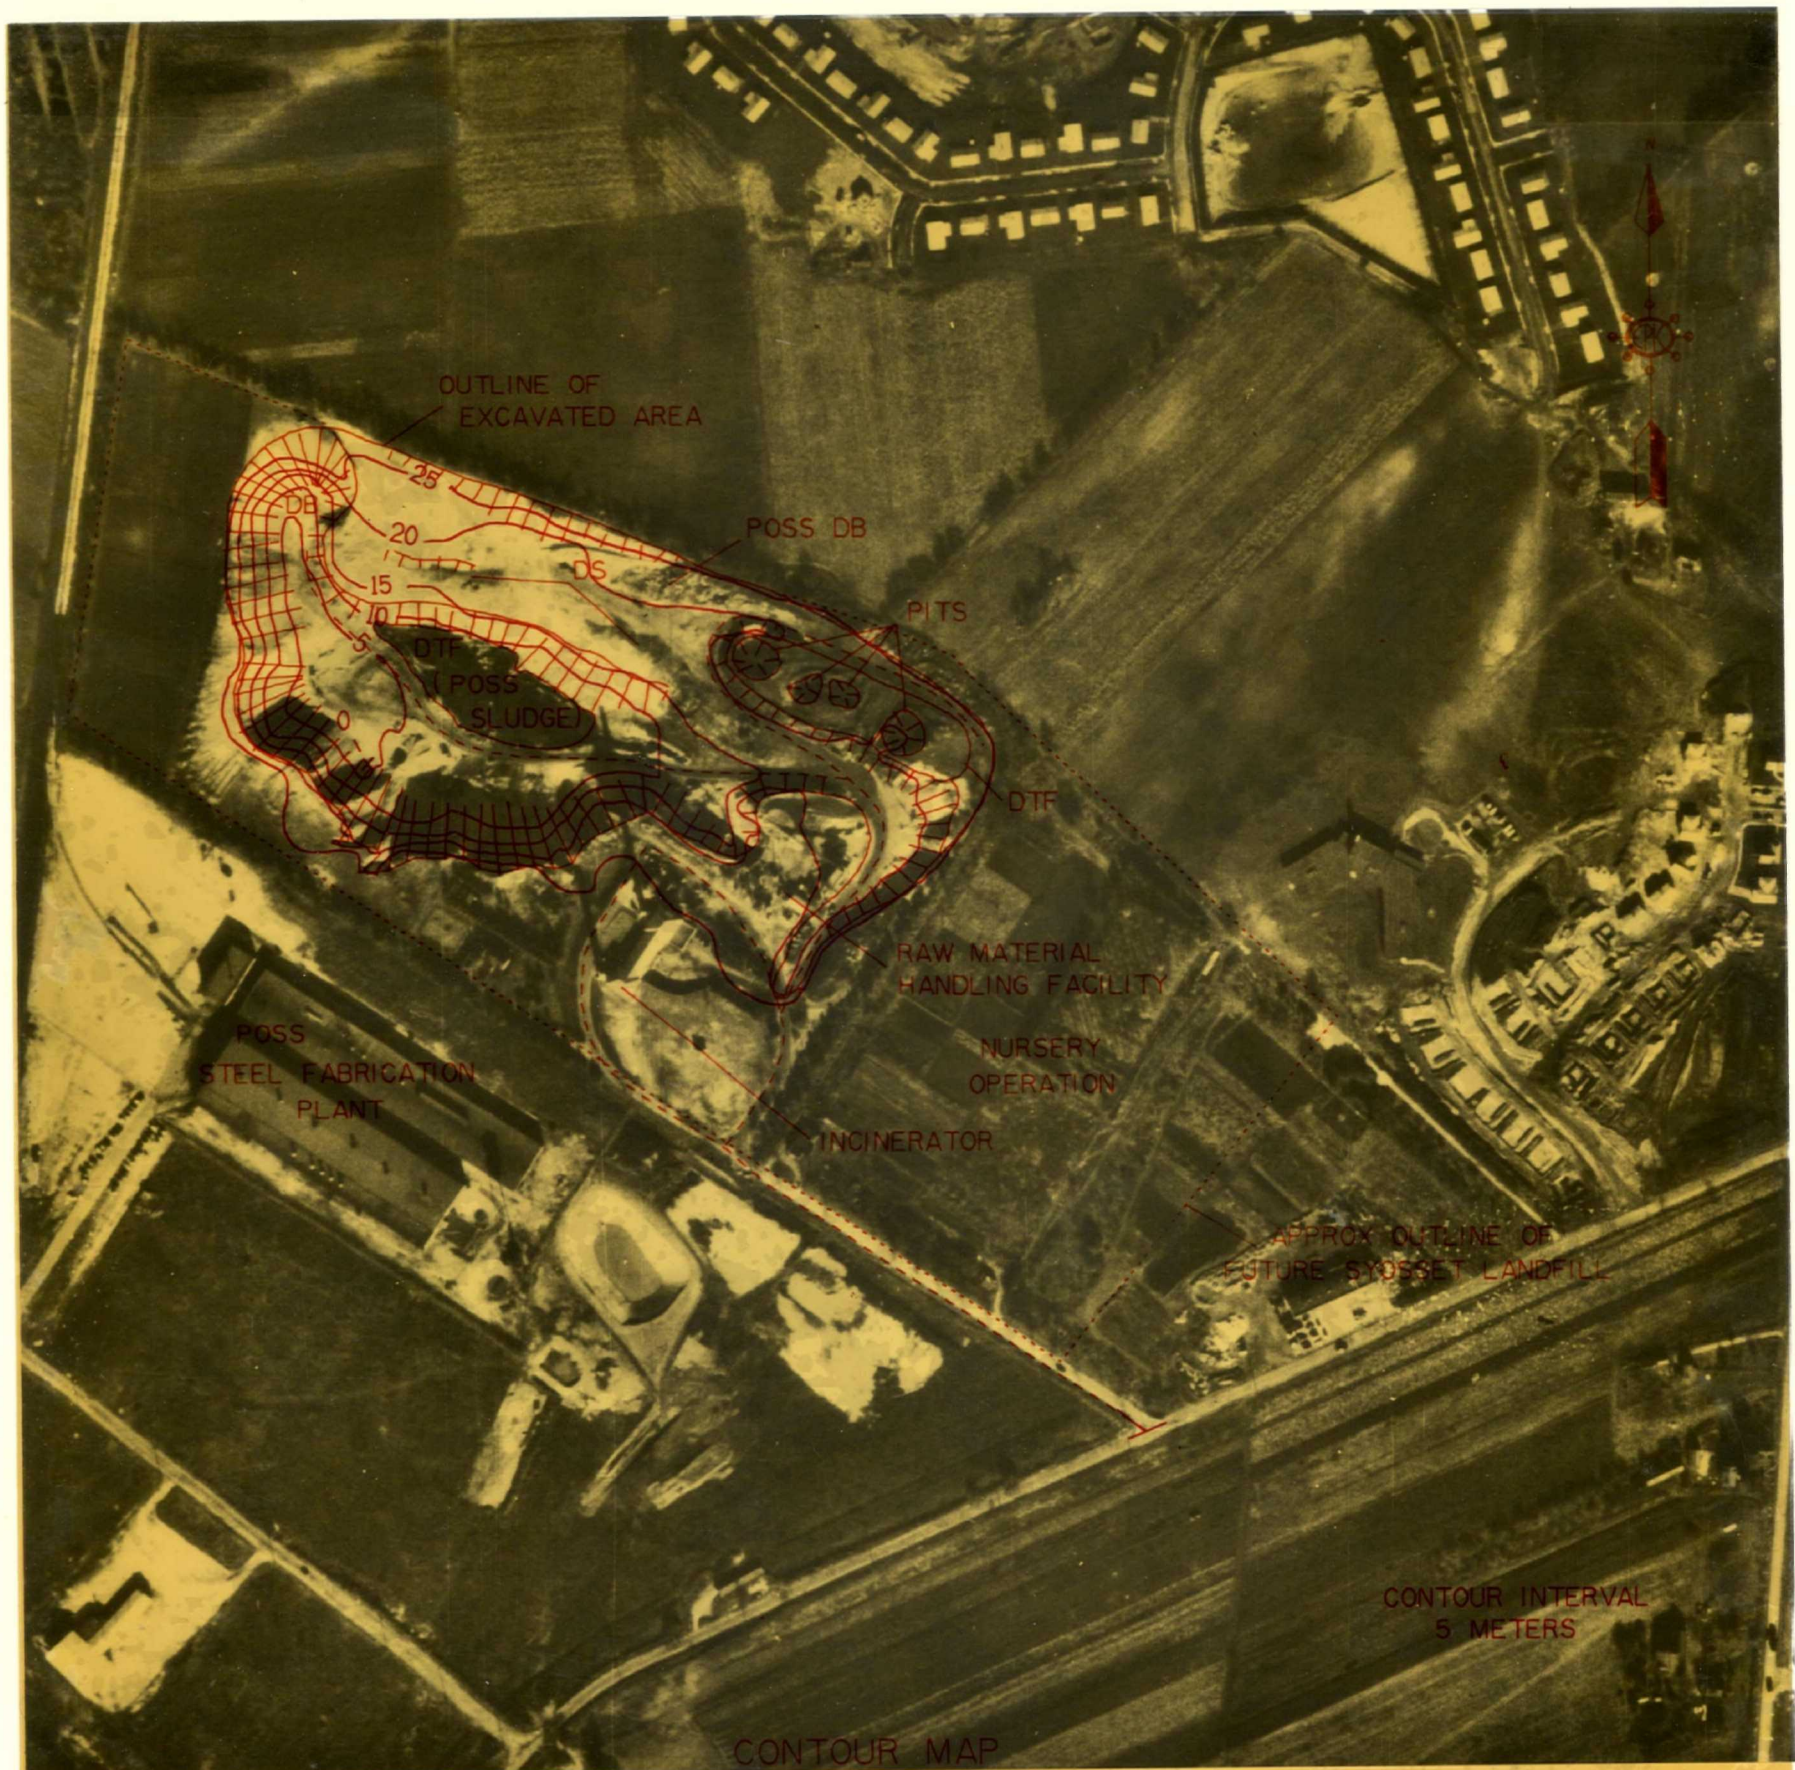
PHOTO 2 SYOSSET LANDFILL DECEMBER 2, 1953 APPROX SCALE 1:4,000

Considerable activity has occurred on site since 1938. A large active excavation occupies approximately 6 hectares (15 acres) of the northwest portion of the outlined site. The lowest portion of the pit lies approximately 23-28 meters (75-92 feet) below the unexcavated ground that surrounds the site. Dark-toned fill (DTF) (possible sludge) covers approximately 0.4 hectares (1 acre) at the bottom of the excavation. This fill lies approximately 21-24 meters (70-80 feet) below the unexcavated ground surface south of the site. Dark staining (DS) can be seen at two areas on a higher level of the excavation just north of the dark-toned fill. Possible debris (DB) piles are located in the northwest and north central portions of the excavation. Four unlined pits or lagoons have been constructed on top of an area of dark-toned fill (DTF) in the northeastern portion of the excavated area. Possible shallow accumulations of dark liquid occupy the bottom of these pits.

Additional features seen adjacent to the excavation and within the future landfill site are: a raw material handling facility, a new incinerator, and a nursery operation. A possible steel fabrication plant and its associated grounds are located just south of the site.

A rough contour overlay (contour interval = 5 meters), starting at 0 at the bottom of the excavation and increasing to 25 meters at the upper edge of the excavation, is also included. This overlay shows a rough three-dimensional configuration of the excavation in 1953, when it appears at its greatest depth. The following approximate areas, measured from each contour line, represent the area of the extraction pit that is below that contour line. Measures are given in hectares, with the corresponding acreage in parentheses (1 hectare = 2.471 acres).

0-5 m	=	0.4 (1.0)
5-10	=	1.9 (4.7)
10-15	=	2.6 (6.4)
15-20	=	4.7 (11.6)
20-25	=	6.9 (17.0)

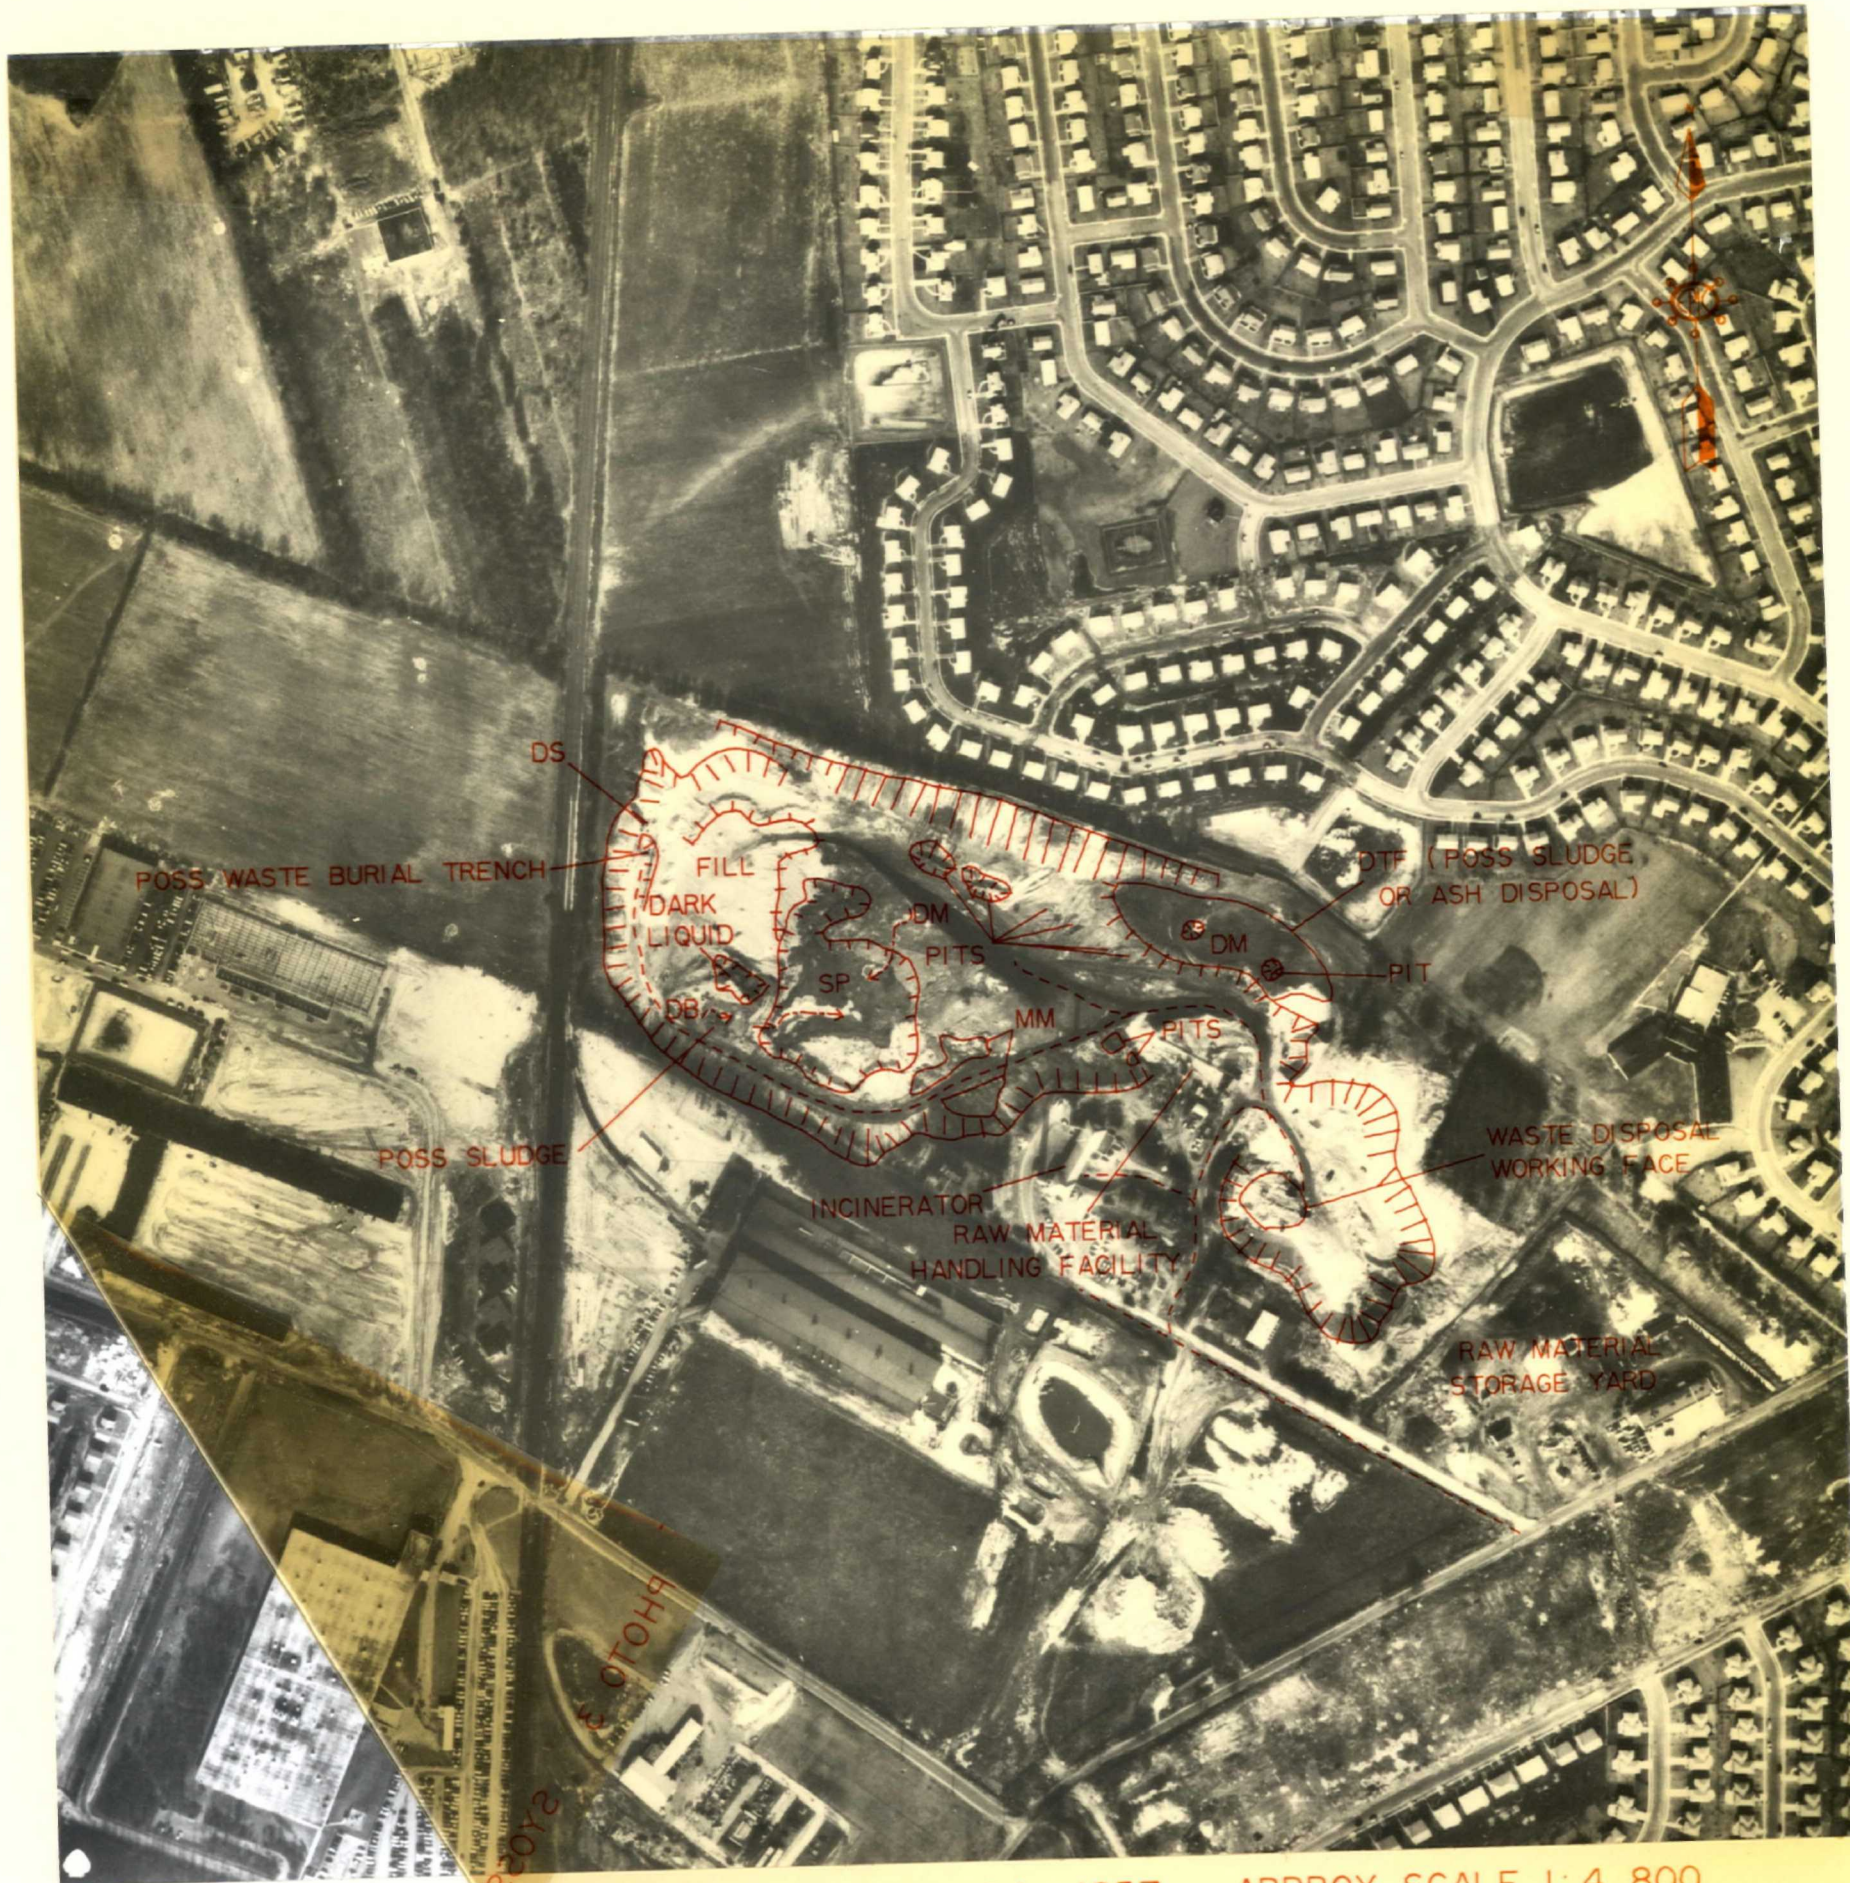
LANDFILL JANUARY 24, 1957 APPROX SCALE 1:4,800

The excavation in the western portion of the site has expanded to the west and south, while filling has occurred in its interior. This extraction/disposal area encompasses approximately 10 hectares (25 acres) and varies in depth from 12-20 meters (40-66 feet). A large pit, lying 15-20 meters (50-66 feet) below the ground surface, contains light- and dark-toned sludge. Drainage patterns indicate that light-toned liquid or sludge has been poured onto the ground and allowed to drain into the pit from the northern and southwestern rims of the pit. Dark liquid has pooled in a rough depression west of the large sludge pit. A small pile of debris (DB), a mound of possible sludge and a stream of light-toned liquid are located just southwest of this dark liquid. In addition, it appears that debris is being buried in a trench near the western wall of the excavation.

North of the sludge pit, dark material (DM) (possibly dry sludge) has been spread out across the fill in a linear pattern. This material lies approximately 12-15 meters (40-50 feet) below the unexcavated area north of the site. North of this dark material several pits have been dug into the north face of the excavation. These pits appear empty.

Two pits containing dark liquid or sludge are located adjacent to the excavation wall near the raw material handling facility. The access roads that lead to the various areas of dumping and filling in the excavation appear darkened, as if they are stained or dark material has been spread out along their length. Mounded material (MM) of varying tones has been dumped on both sides of the southern access road in the southeast portion of the excavation.

The incinerator and raw material handling facility east of the large excavation/disposal area appear active.

The dark-toned fill (DTF) to the north (area of possible ash or sludge disposal) remains; however, the four pits seen in 1953 have been graded level. A small, light-toned depression and an additional pit can now be seen on the dark-toned fill.

A newly excavated area of approximately 3 hectares (7 acres) has been created in the southeastern end of the site, where the nursery was located in 1953. This excavation is approximately 14-17 meters (46-56 feet) deep at its lowest point.* Some of the excavated material from this area is probably being used as cover material in the western section. Access roads lead directly from this area into the western section of the site.

Waste disposal is also evident in this eastern excavation. A small working face with several possible trash trucks and an operating bulldozer are located in the southwest corner. Several other vehicles and two cranes that are scattered around the excavation indicate active extraction.

A new raw material storage yard fronting on Miller Place Road contains piles of earthen-like material.

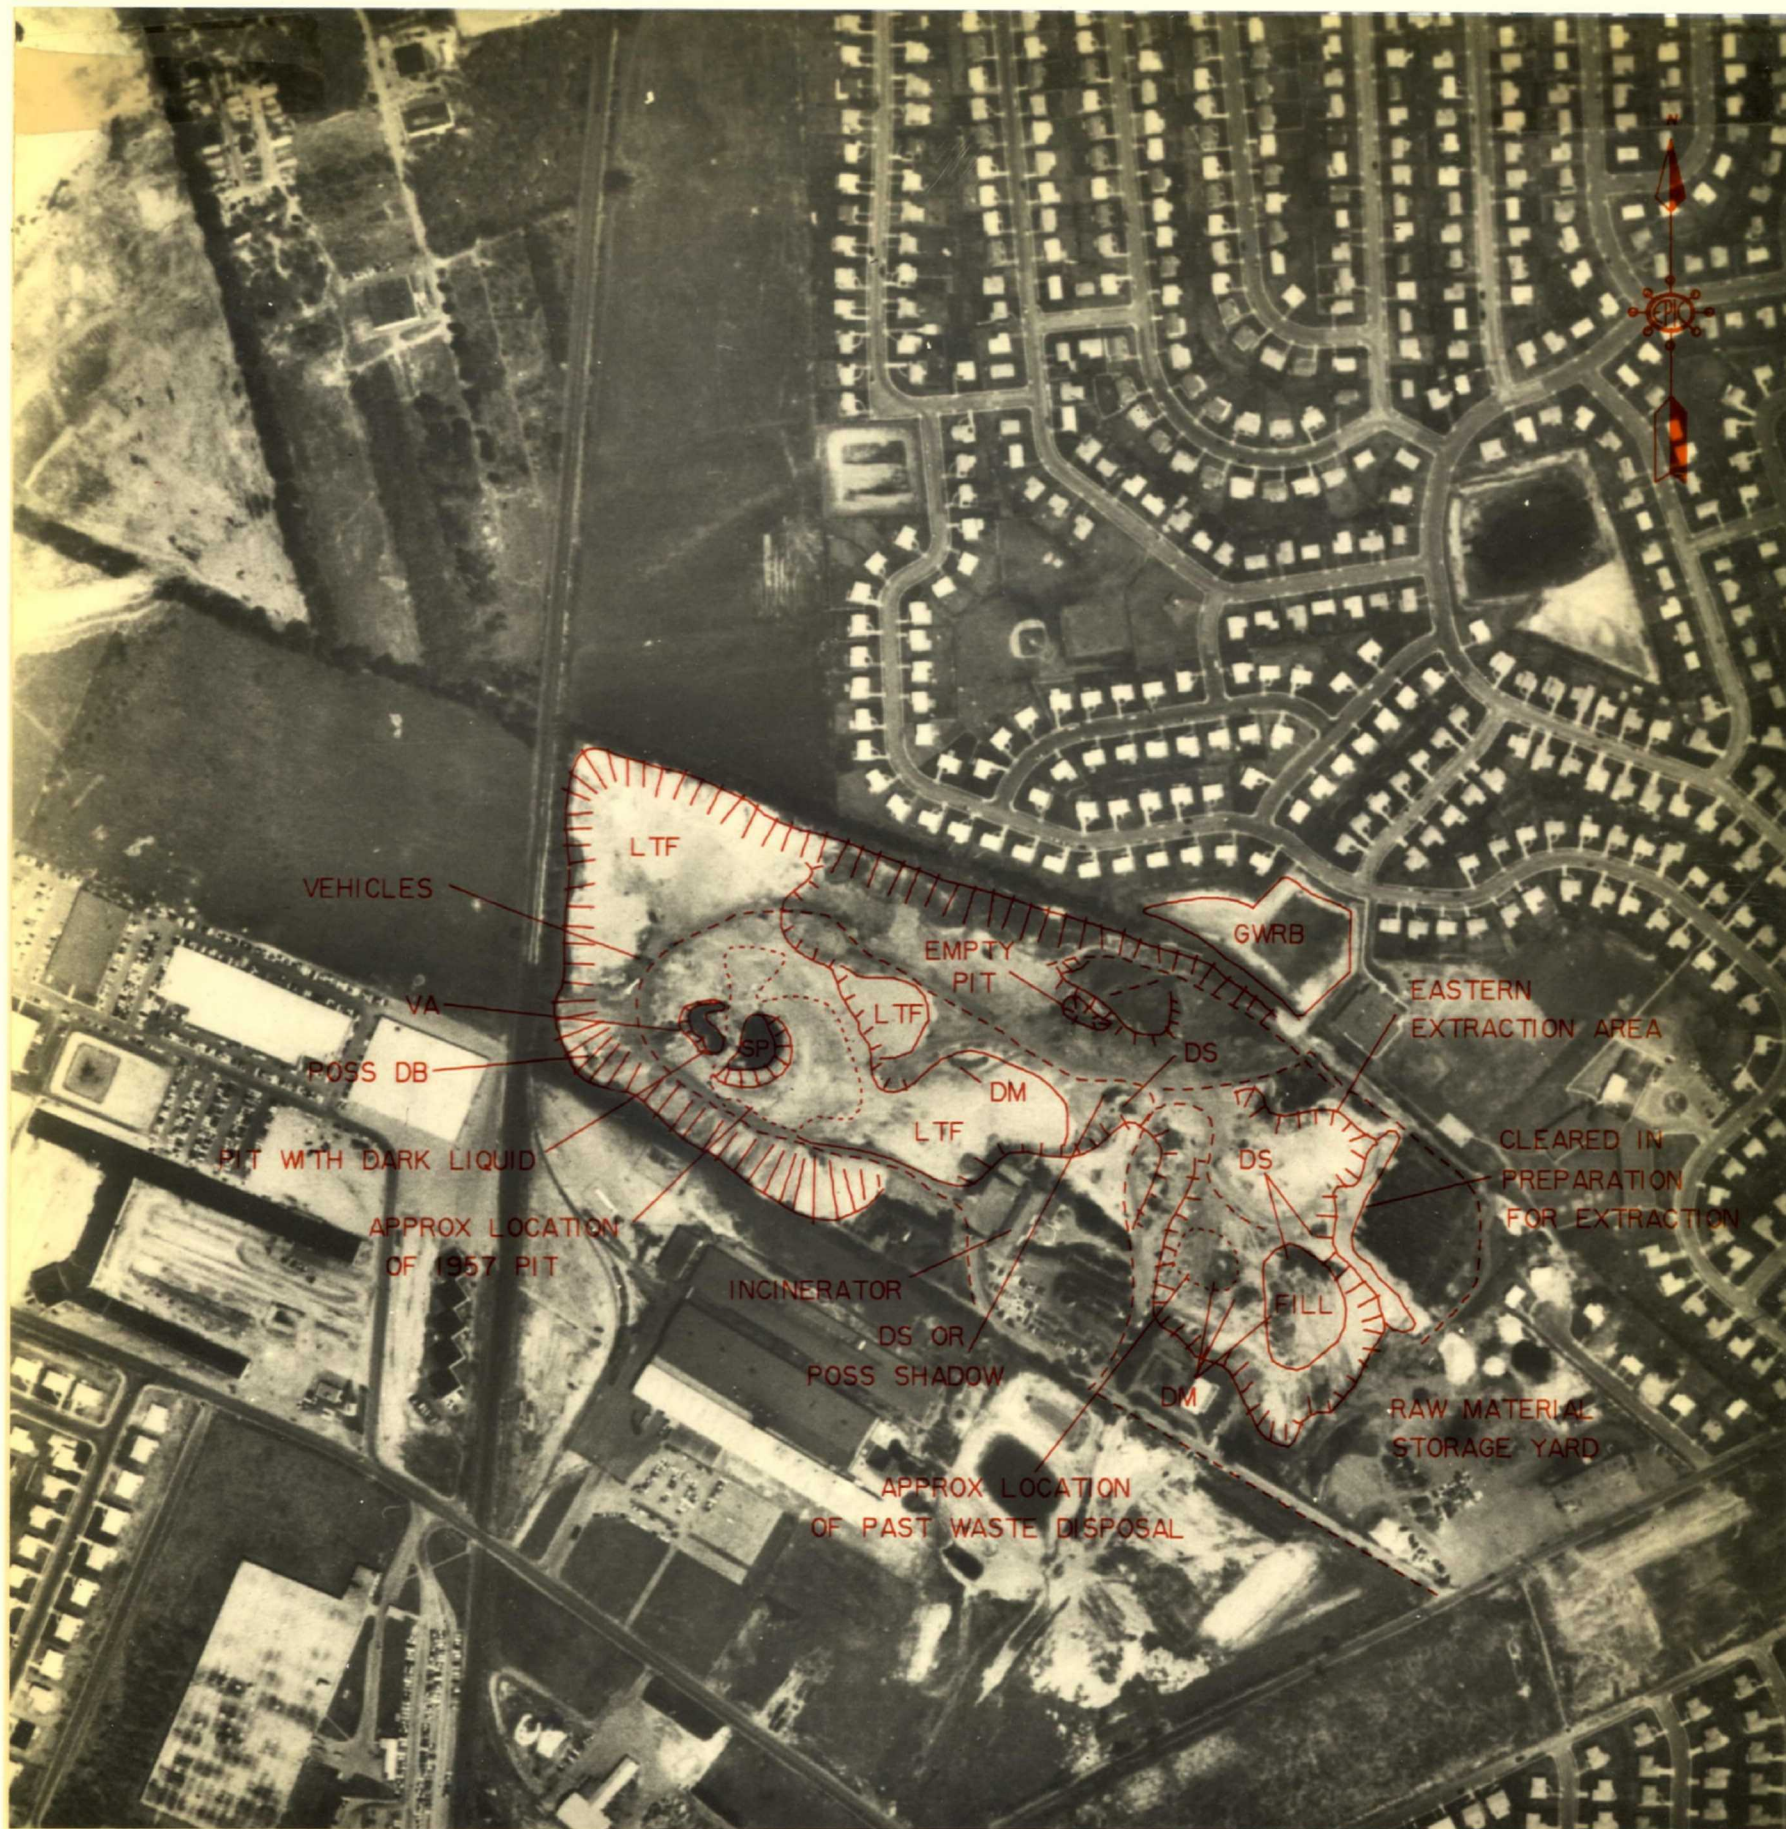
PHOTO 4 SYOSSET LANDFILL MAY 4, 1959 APPROX SCALE 1:5,000

- 1959 - (Photo 4) The excavation area in the west is being filled with light-toned fill (LTF). A liquid and sludge disposal pit, approximately 12-15 meters (40-50 feet) deep, is present in this area. Both liquid and sludge are evident in the pit area. Dark staining (DS) and dark material (DM) are visible in the excavated area at the east end of the site.

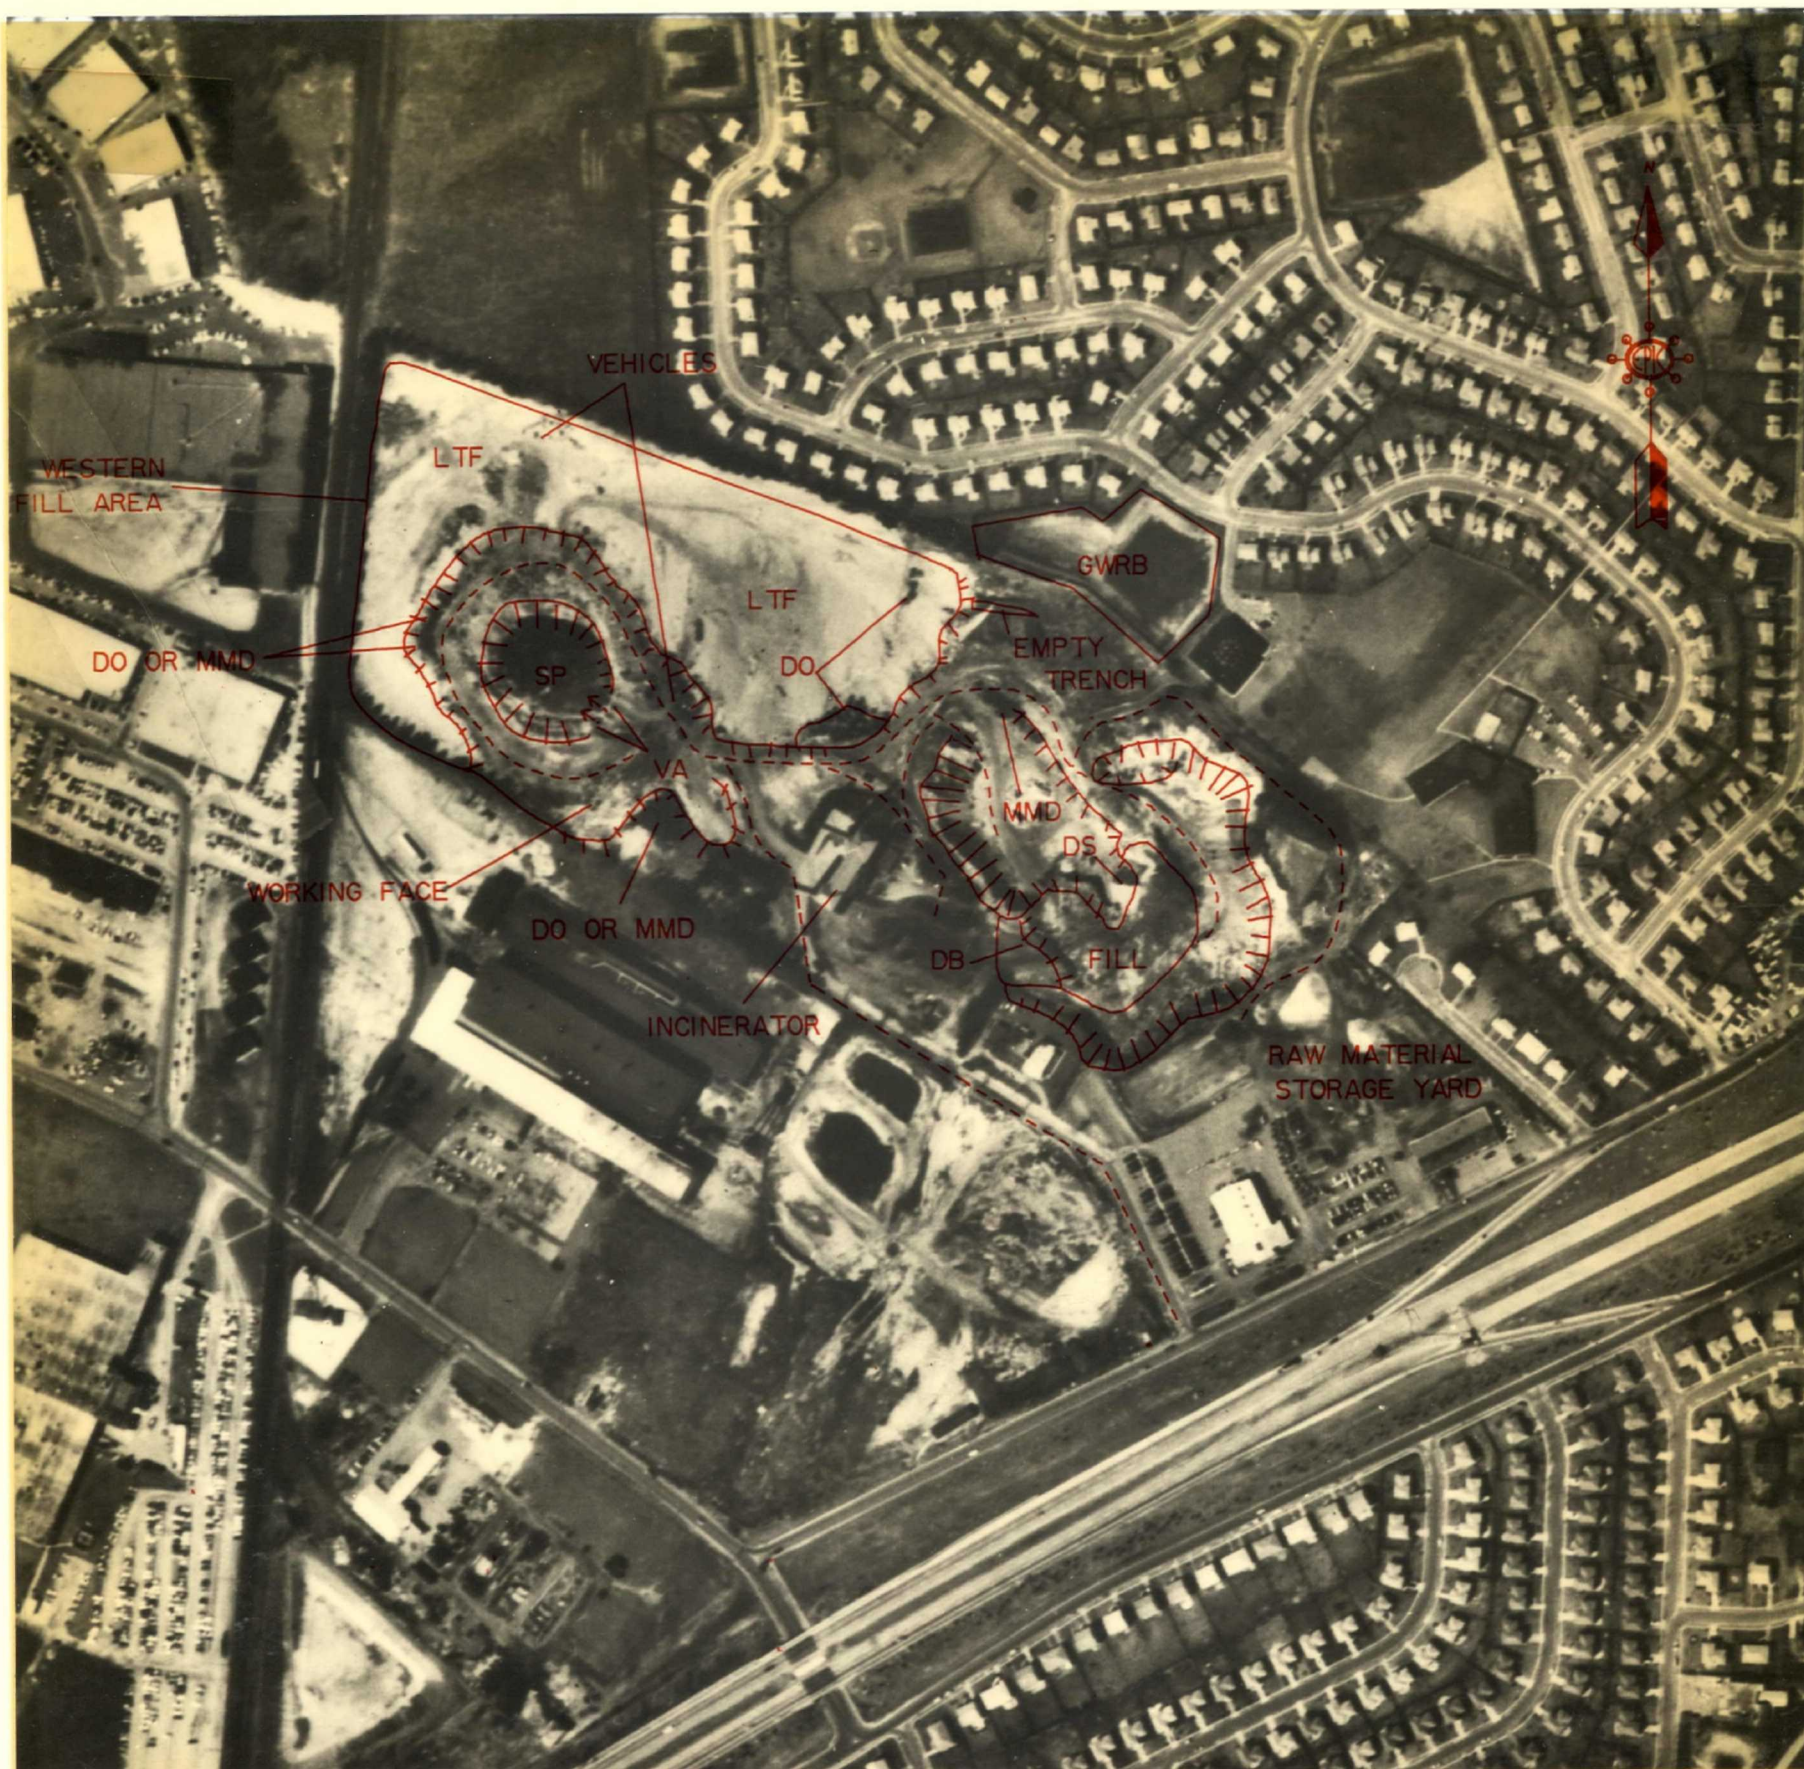
PHOTO 5 SYOSSET LANDFILL MARCH 23, 1962 APPROX SCALE 1:4,800

The western fill area has expanded outward towards the northeast. The two pits seen in 1959 have been enlarged to form one large liquid and sludge disposal pit. This pit is roughly circular and lies approximately 8-11 meters (26-36 feet) below the unexcavated surface. Material, including probable rubble, has been mounded around its perimeter. Vehicle access (VA) to the pit is from the east. Probable flow direction of waste liquids and sludge is shown by the small arrows at the vehicle access point.

The fill is primarily light-toned (LTF) (probably indicative of the cover material used) with darker-toned fill in the southeast area and around the pit. There are many vehicles in this western portion of the site; the two largest concentrations are shown on the photo overlay.

Southeast of the large sludge pit is an active working face of the landfill. The fill appears to be progressing in a southeasterly direction and is encroaching on a large pile of dark-toned mounded material (MMD) or dark-toned objects (DO). The imagery scale precludes positive identification of these objects or material. This area is filled or covered by 1963. Larger dark-toned objects are also seen in two areas--near the eastern end of the fill and west of the sludge disposal pit.

In the north central portion of the site adjacent to the light-toned fill is a crude empty trench of undetermined function. It is located just north of the pit seen in 1959 and becomes part of the eastern excavation area by 1963.

The incinerator appears operational; however, vehicle parking in this area has been drastically reduced, indicating that it may no longer be used.

Extraction activity has continued in the eastern section of the site. The excavation has expanded eastward and westward around the fill. Again, the outline of the fill shown on the overlay is a "best approximation." A small amount of debris (DB) appears on this fill area.

Vehicles and equipment in the newly excavated areas indicate current extraction activity. In addition, some dark material (MMD) has been dumped in the shallow, northwest portion of the excavation. Dark staining (DS) is visible near the center of the extraction area.

There has been a marked increase in the number of vehicles and equipment stored in the raw material storage yard.

- 1962 - (Photo 5) The liquid and sludge disposal pit is roughly circular in shape and has been reduced to 8-11 meters (26-36 feet) deep. Additional filling activity (LTF) surrounds the pit. Several piles of dark objects (DO) or dark mounded material (MMD) are found east of the pit. (These are covered by 1963.) The extraction area at the east end comprises 4 hectares (10 acres) in area, and two areas of possible sludge disposal are present. The incinerator appears inactive.

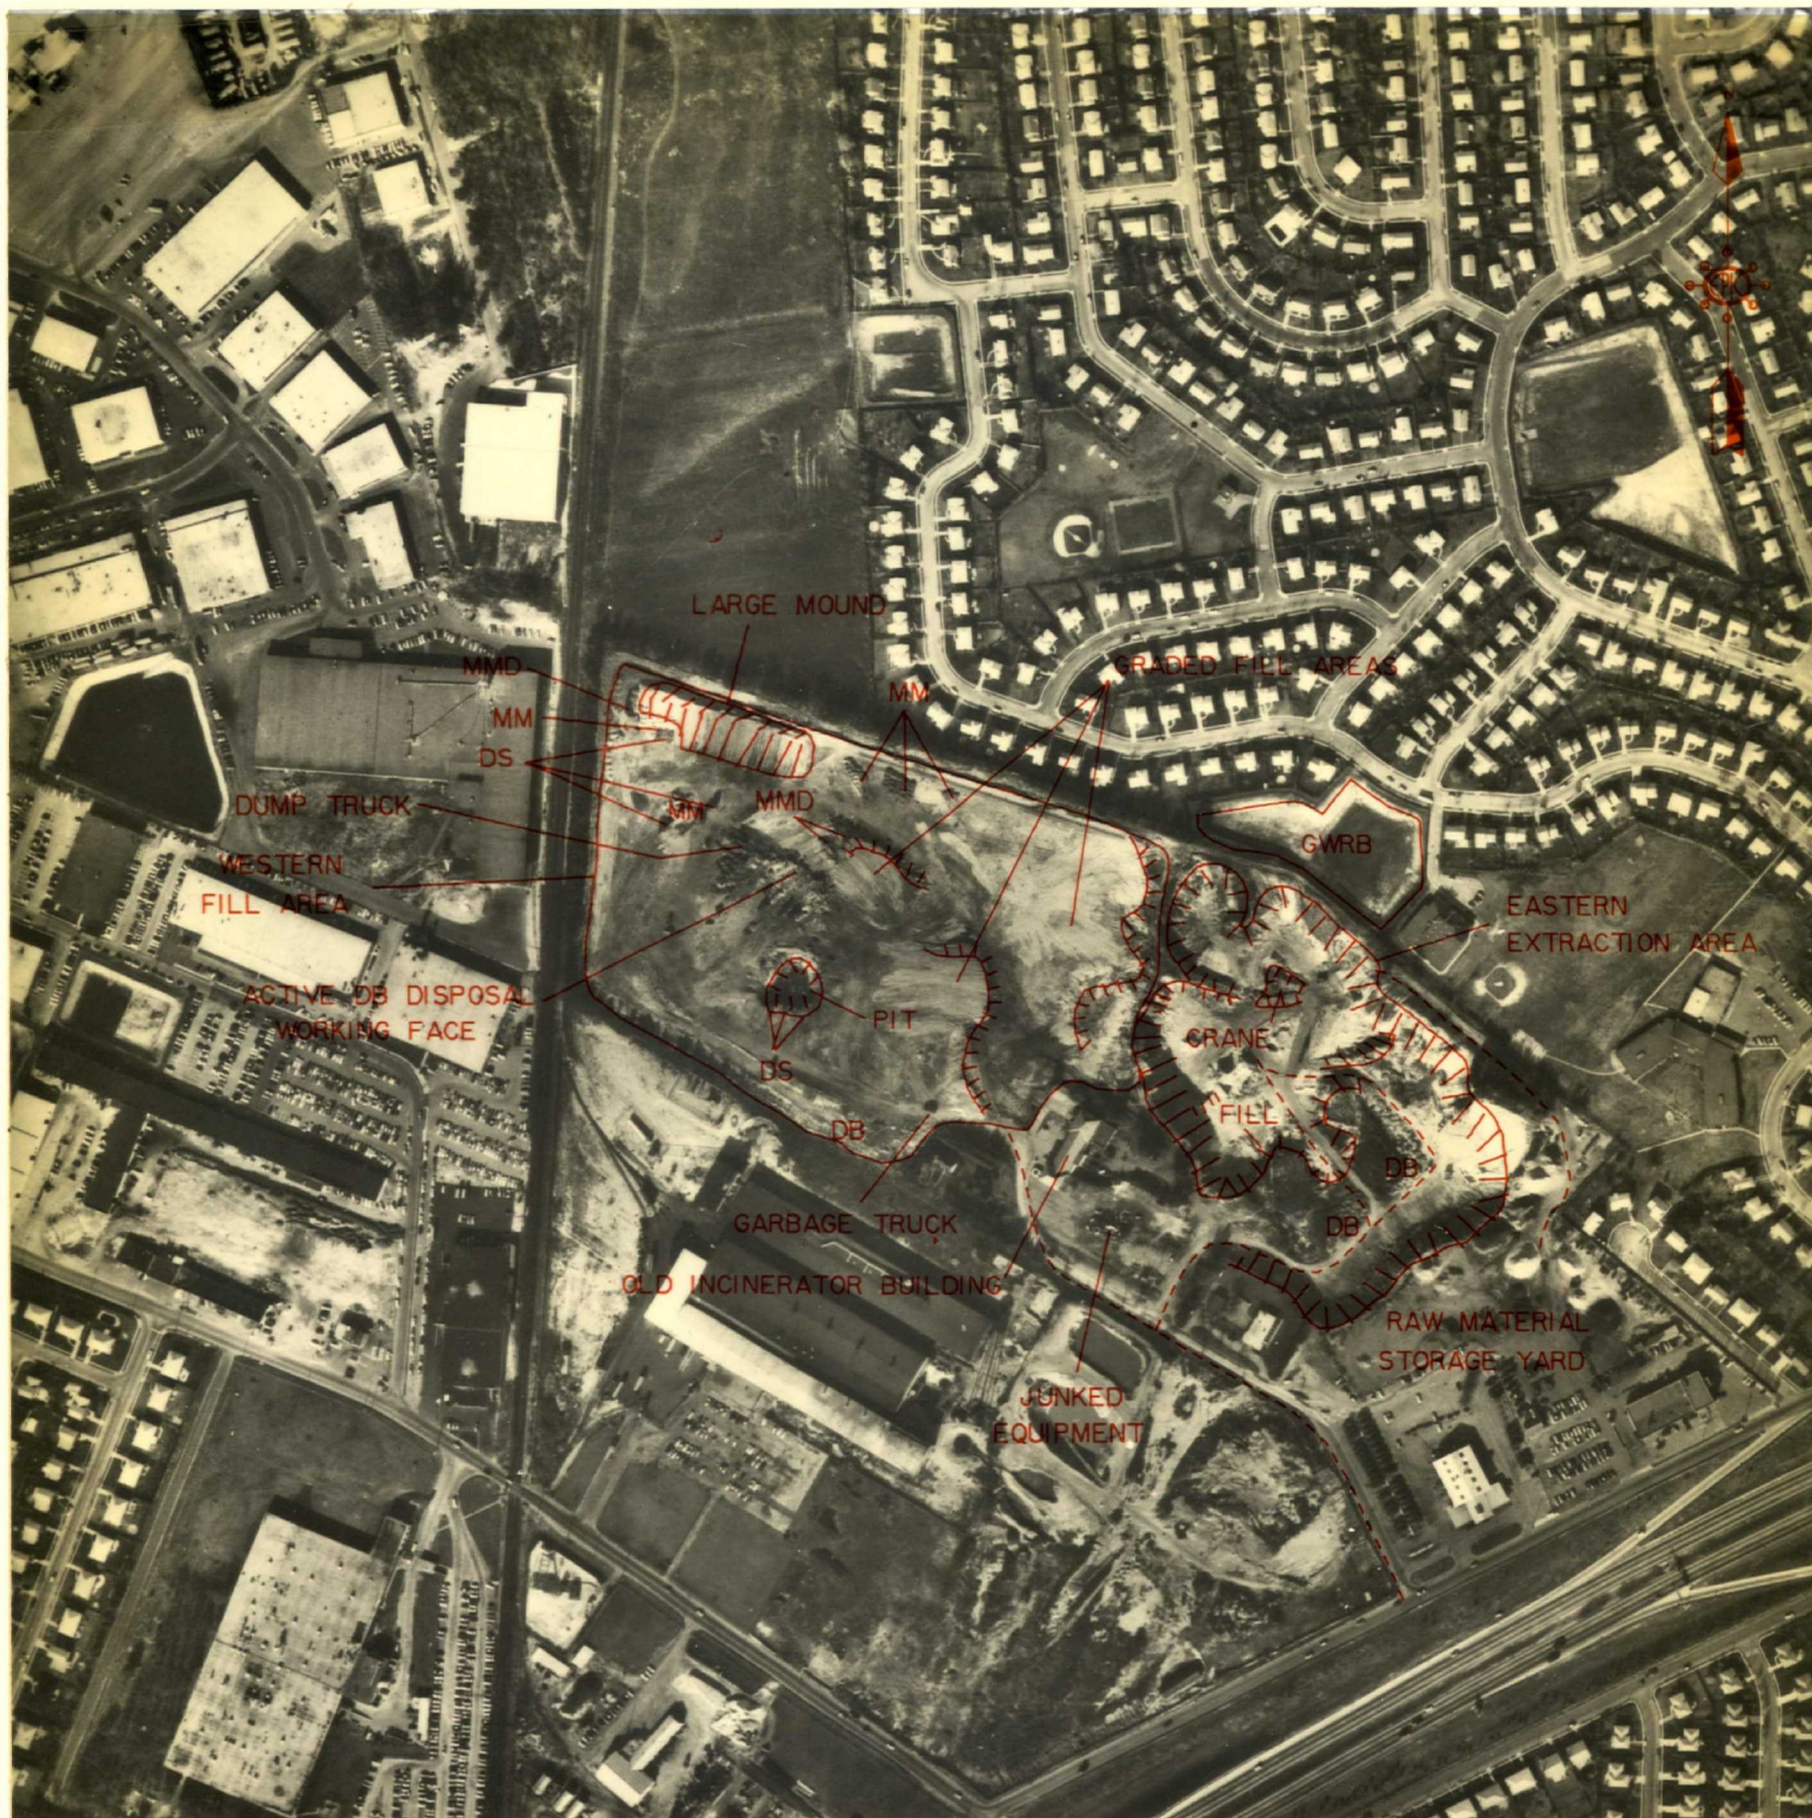
PHOTO 6 SYOSSET LANDFILL NOVEMBER 20, 1963 APPROX SCALE 1:4,800

Considerable fill activity has occurred on the western half of the site. The fill area now encompasses approximately 8 hectares (20 acres) and is raised approximately 1-4 meters (3-13 feet) above the unexcavated terrain.

The liquid/sludge disposal pit is still present; however, it has been reduced considerably in area and now lies only 4-7 meters (13-23 feet) below the fill surface. No standing liquid is evident in the pit, although dark staining (DS) along the southern wall suggests past liquid disposal.

An active debris disposal working face lies northwest of the pit. Both moving and stationary vehicles and equipment (garbage trucks and a dump truck), debris and cover material are present there. Just to the north is an older working face with some debris still exposed (MMD).

A large mound and numerous smaller piles of light- and dark-toned earthen material (MM) (probably cover material) can be seen near the northern edge of the fill. In the northwesternmost corner, adjacent to the large mound, is some very dark mounded material (MMD). Its texture suggests that it may be dried sludge or a pile of small dark objects. This dark material is being covered with mounds of earthen material. There are also three areas of dark staining (DS) in the northwest portion of the fill. Two of these appear to be in the process of being covered with mounded material (MM). A small amount of debris or a few small objects are in the northernmost stained area. Exposed debris (DB) is also evident along the southeastern edge of the fill. A garbage truck is entering the site near this debris.

The eastern extraction area has expanded to the northeast and now occupies approximately 4.5 hectares (11 acres). Active excavation can be seen in the new northeastern excavation. Possible debris piles (DB) or mounded material are located along the fill edge.

The stacks of the incinerator building have been removed. A pile of junked and dismantled equipment can be seen in the parking lot adjacent to the old incinerator.
